MISSOURI-NEMAHA-NODAWAY BASIN

102 RIVERS, C-5 DAM
NODAWAY COUNTY, MISSOURI
MO. 10996

PHASE 1 INSPECTION REPORT NATIONAL DAM SAFETY PROGRAM

MAY, 1979

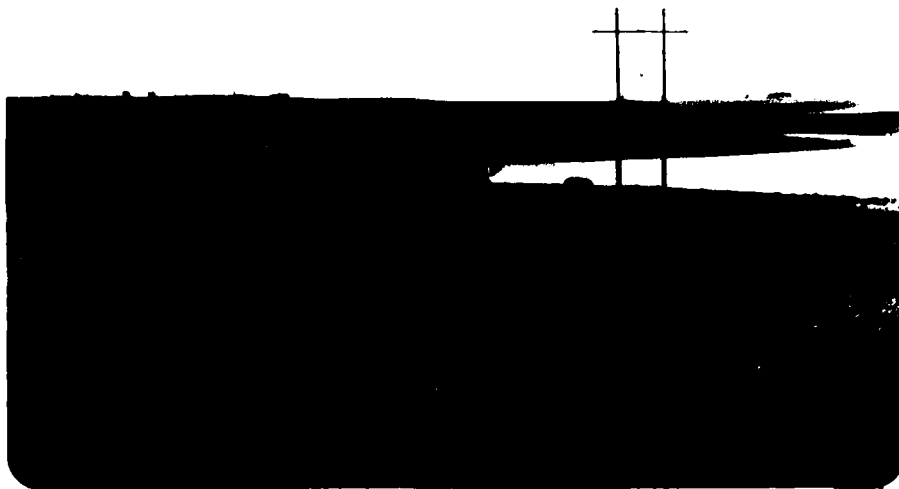
PHOTO NO. 2 - DAM FROM LEFT ABUTMENT. UPSTREAM END OF
EMERGENCY SPILLWAY LOCATED AT RIGHT-CENTER
OF PHOTO.

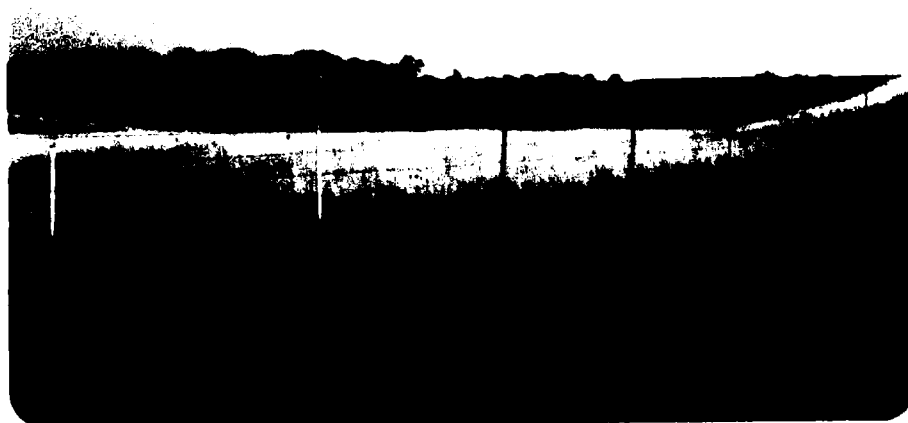
PHOTO NO. 3 - LOOKING DOWNSTREAM IN EMERGENCY SPILLWAY

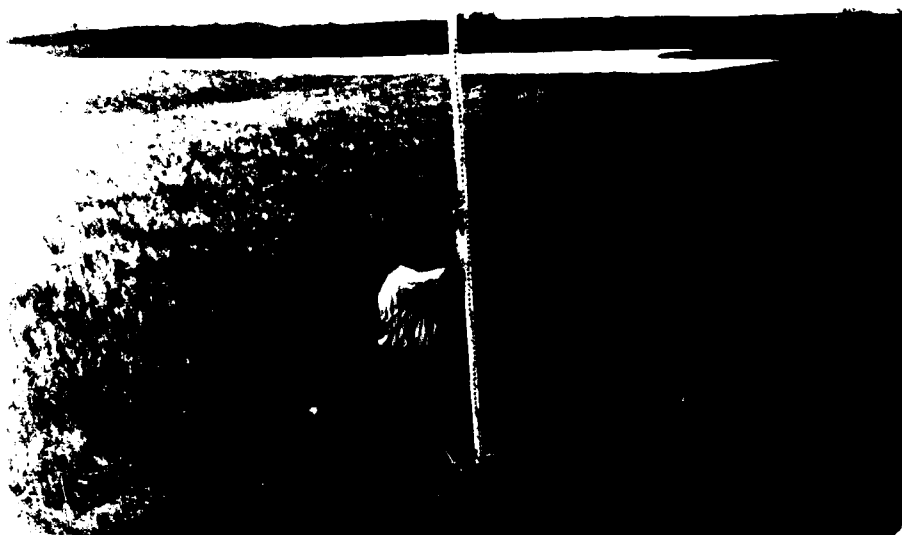
PHOTO NO. 4 - LOOKING UPSTREAM IN EMERGENCY SPILLWAY

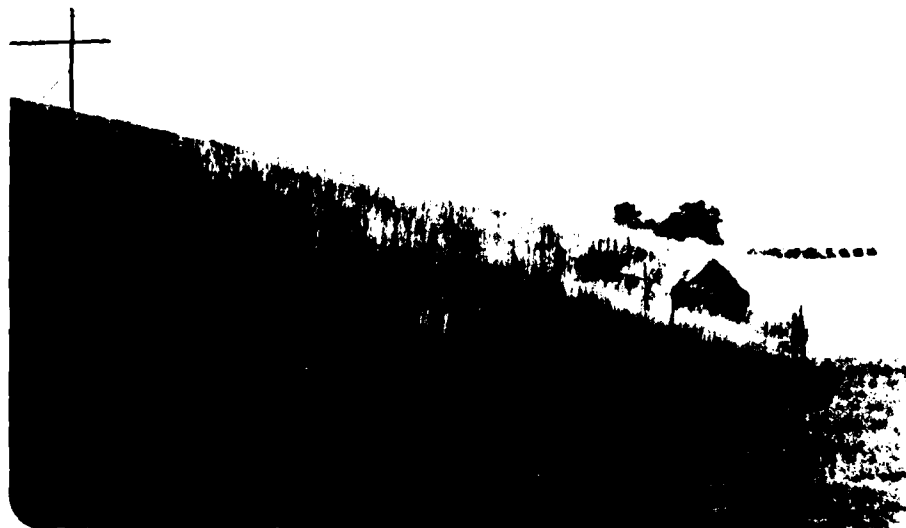
PHOTO NO. 8 - DOWNSTREAM SLOPE FROM RIGHT SIDE
